PROPERTY INSPECTION REPORT

Inspected on Saturday, 09 June 2012 at 10:00 AM.

Your Inspection Order number is 2475

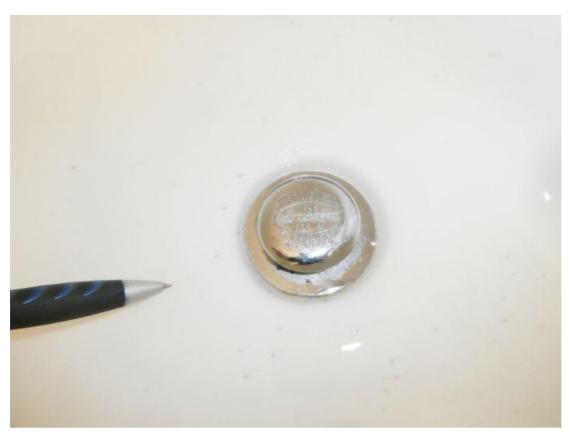
Bathroom #2 Hall	Ò	Good	Fair	Poor	Comments
downstairs					
Walls		X			(Drywall). General condition appears normal.
Door(s)		X			
Counter Tops		X			
Cabinets		X			
Sink		X			Note: functional flow at faucet appears normal; Sink appears to drain in a normal manner. No active leak at time of inspection.
Bath Tub stopper leaked	1	X	X		Drain stopper leaked.Note: functional flow at faucet appears normal; Tub appears to drain in a normal manner.
Shower/Diverter leaked	1	Х	X		Diverter leaked Note: functional flow appears normal; Shower appears to drain in a normal manner. No active leak observed at time of inspection.
Shower Enclosure		X			(Curtain). not evaluated.
Toilet		X			Note: no active leak at time of inspection.
Sink Plumbing		Х			No leaks observed at time of inspection. Note: Inspector does not turn shut-off valves under sink.
GFI(s)/Hot Neutral reverse	1	X		Х	Outlet tested hot / neutral reversed at sink counter. Recommend evaluation repair by licensed electrician.

Bathroom #2 Hall downstairs / Bath Tub stopper leaked

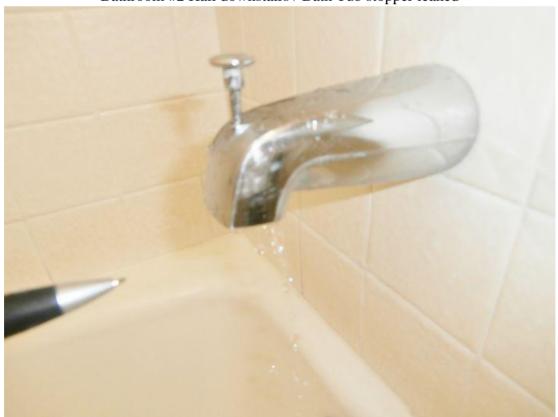
Bathroom #2 Hall downstairs / Shower/Diverter leaked

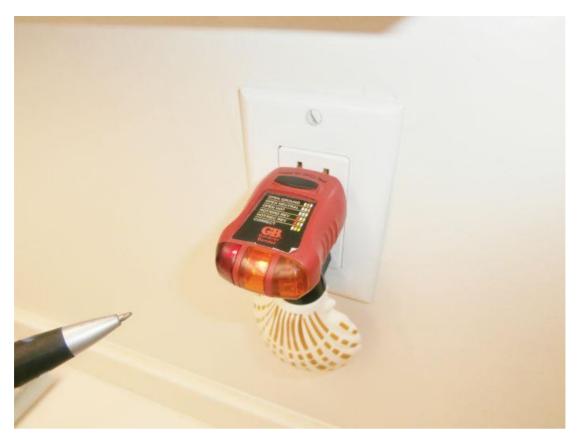
Electrical		X		Χ	GFI Outlet tested hot / neutral reversed at sink counter.
Ceiling		X			(Drywall). General condition appears normal.
Floor		X			Ceramic tile.
Windows		X			
Picture	1	X

Bathroom #2 Hall downstairs / GFI(s)/Hot Neutral reverse

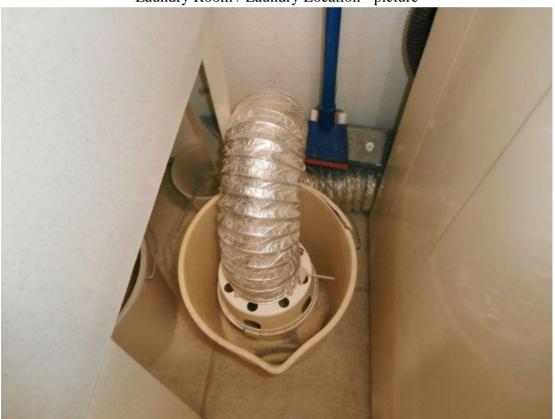
Laundry Room		Good	Fair	Poor	Comments
Laundry Location - picture	1	Х			Located in garage.
Walls		X			
Doors					
Dryer Vent	1		X		Unable to view most at time of inspection. Recommend further review. Not connected.
Waste Line	1	Х			Limited inspection, viewed at wall box only, unable to view most of waste line.
Electrical		X			120 volt and 240 volt outlets appeared serviceable.
Counter Tops		X			
Cabinets		X			
Laundry Sink		X			Note: no active leak at time of inspection.
Exhaust Fan					
Windows					
Ceiling		X			
Floor		X			Ceramic tile.

Laundry Room / Dryer Vent

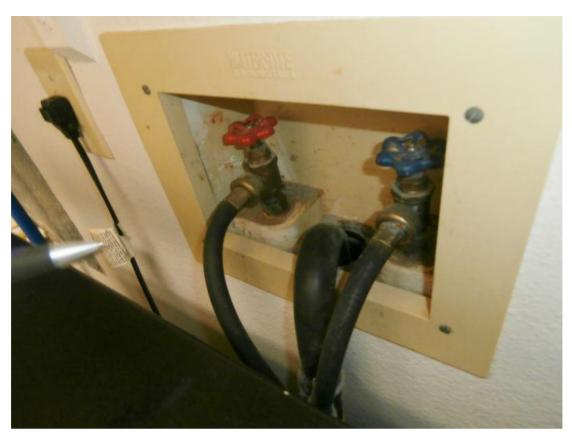
Laundry Room / Waste Line

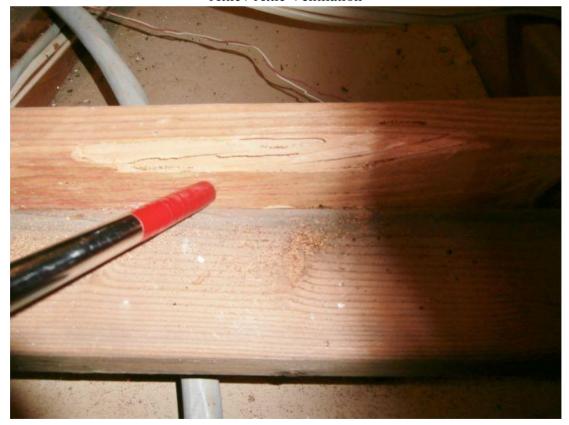
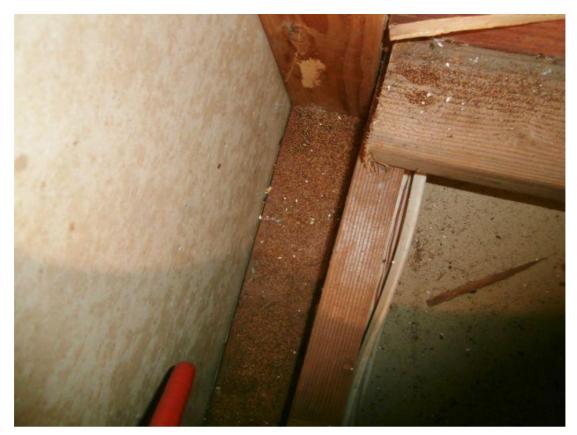
Attic	û	Good	Fair	Poor	Comments
Rafter/framing	2	X			
Insulation					
Attic Ventilation	1	X			
Duct Work					
Attic Electrical		X			
Attic notes		X			Two attics inspected.Both attics not fully accessible due to low contruction height and type of contruction.
Joist damaged	1	Х	X		Floor joist in lower attic appeared insect damaged in lower level attic 10 ft. right of entry.
Insect droppings noted	1	Х			Insect droppings noted near damaged joist in lower level attic 10 ft. right of entry.
Damaged cable junction box.	1	Х			Left of lower attic entry.

Attic / Joist damaged

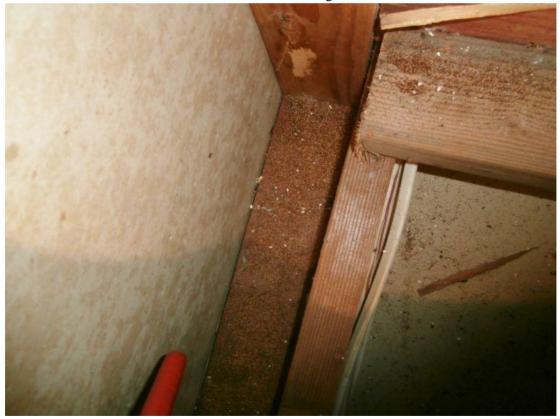
Attic / Insect droppings noted

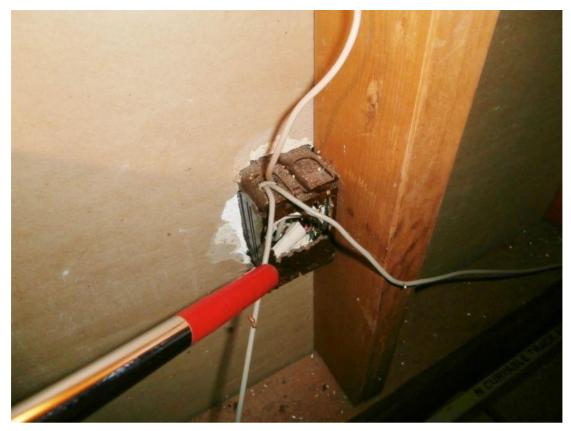
Attic / Damaged cable junction box.

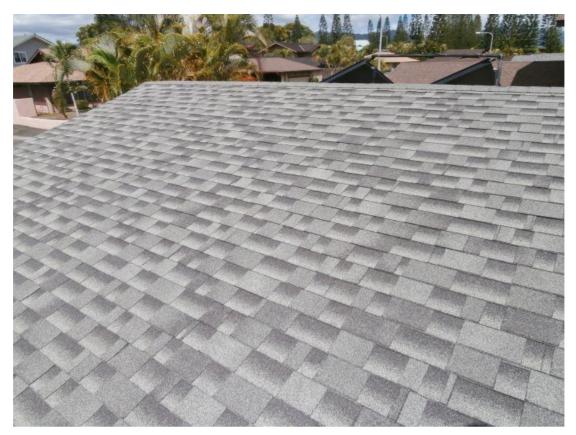
Roof / Condition #1

Roof		Good	Fair	Poor	Comments
Material		X			Asphalt/Composition Shingle.
Condition #1	1	X			
Flashings	1	X			
Roof: Vents and Vent Caps	1	X			Typical maintenance recommended. This usually consists of repair/replacement of any damaged/missing shakes/shingles. This maintenance should help prevent moisture intrusion and be performed on a regular basis.
Roof Drainage	2	X			
Skylight(s)					
Roof General Info		X			Roof was generally accessible, able to be walked.
Roof gable	1	X

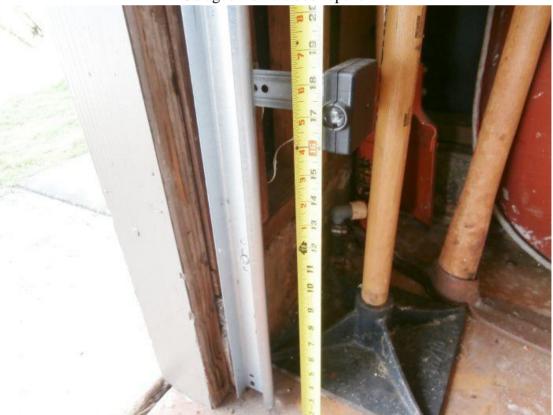
Garage	Û	Good	Fair	Poor	Comments
Garage: Vehicle Door(s)		Χ			
Vehicle door opener	1	X			
Infrared Sensors	1	X	X		Sensors located too far from floor.
Walls		X			
Window(s)		X			
Door to living space		X			Automatic closer present. Fire rated/solid core.
Exterior Door		X			
Garage Electrical hot/neutral reverse	1	X			Hot/neutral reverse at garage west facing wall outlet. Outlet(s) not GFCI protected.
Ceiling	1	Х			er er protostea.
Floor		Χ			Concrete.
GFI(s)					Outlet(s) not GFCI protected. Recommend updating.
Automatic reverse		X			
Wash basin		X

Garage / Infrared Sensors

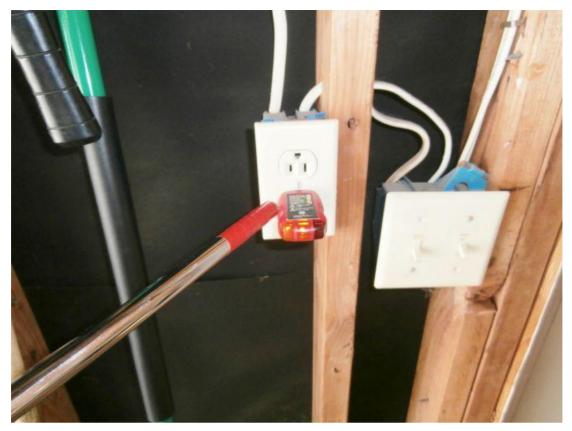
Garage / Garage Electrical hot/neutral reverse

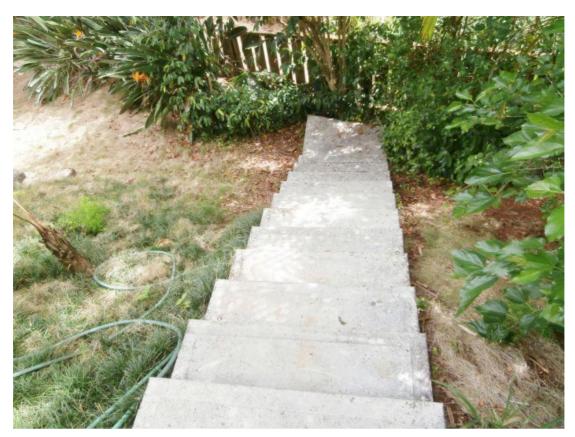
Grounds / Exterior Stairs missing hand rails

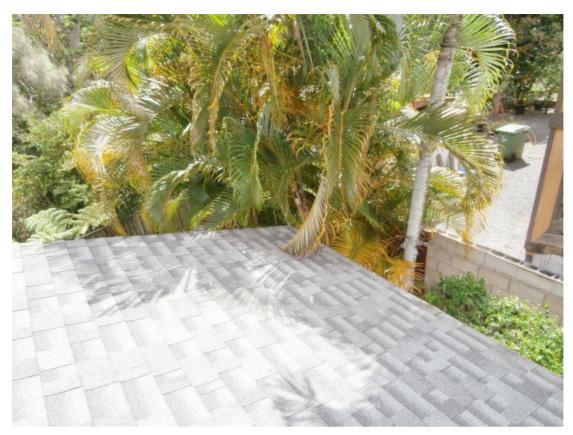
Grounds / Recommend trimming foliage

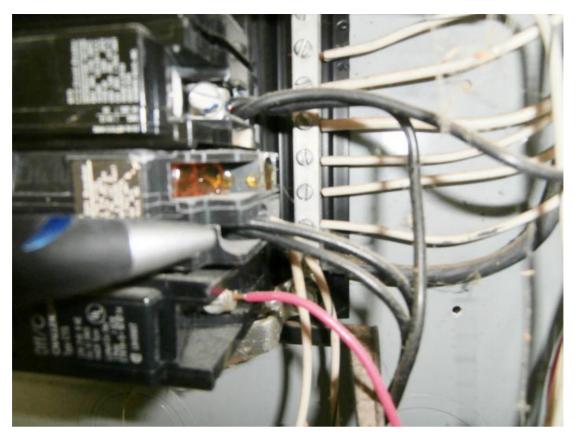
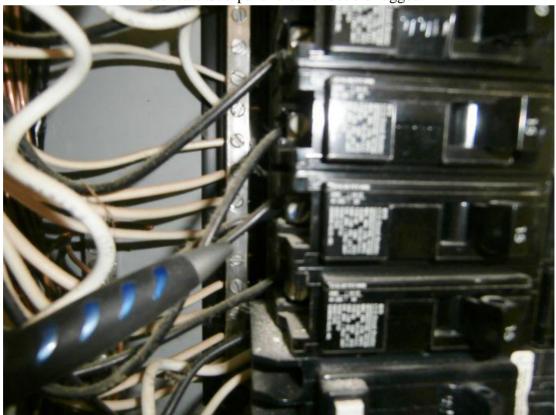
Electrical	D	Good	Fair	Poor	Comments
Entrance Wires		X			Underground, Unable to view.
Amps - Volts		X			120/240 Volts. Main panel rated 125 amps
Meter Location	1	X			Right east facing garage exterior.
Main Panel location	1	X			Right east facing garage exterior.
Main panel Wiring	1	X			
Sub-panel breaker double-lugged.	2	X		X	Two double-lugged circuit breaker.Recommend evaluation repair by licensed electrician.
Ground Location	1	X			Water main at water pressure valve below main panel located at east facing garage exterior.
Sub Panel location	1	X			Bedroom #2 1 left lower level.
Exterior Electrical		X	X		Note: outlet(s) not GFCI protected. Recommend updating.
Electrical Notes		X		X	Hot/neutral reverse at garage west facing wall outlet and GFI located in bathroom #2. Recommend evaluation repair by licensed electrician.
GFI(s)		Х	X		Outlet(s) not GFCI protected at garage. exterior and kitchen sink counter area. Recommend updating.

Electrical / Sub-panel breaker double-lugged.
