PROPERTY INSPECTION REPORT

Inspected on Saturday, 09 June 2012 at 10:00 AM.

Your Inspection Order number is 2475

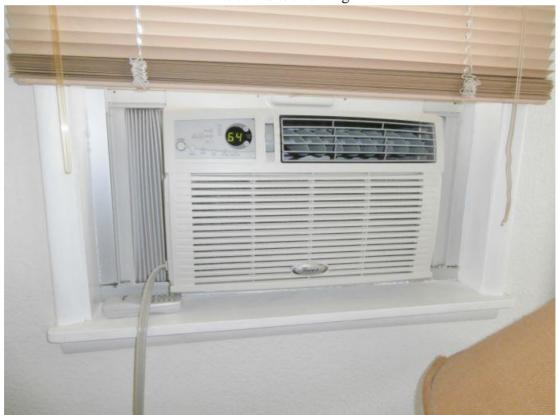
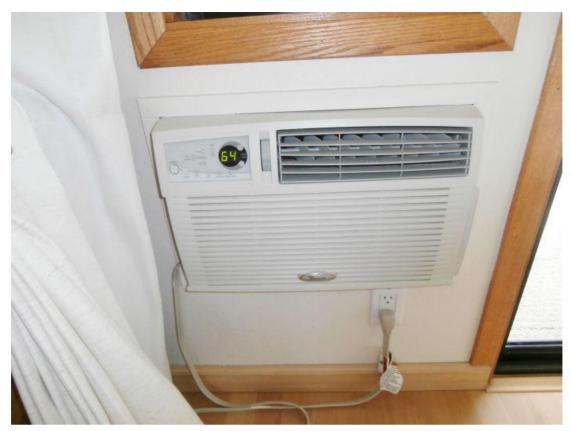
Cooling / A/C Unit Location

Cooling		Good	Fair	Poor	Comments
A/C Unit Location	2	Х			A/C window units located in family room and master bedroom.
Cooling type		Χ			Window units
Cooling Condition		X			
Temp Differentials		X			
Filter(s)		Х			
Thermostat(s)		Χ			
120 volt		Χ
